Eight Years of Experience with Windowless Housing for Poultry

**WEST VIRGINIA UNIVERSITY
AGRICULTURAL EXPERIMENT STATION**

A. D. LONGHOUSE and HOMER PATRICK

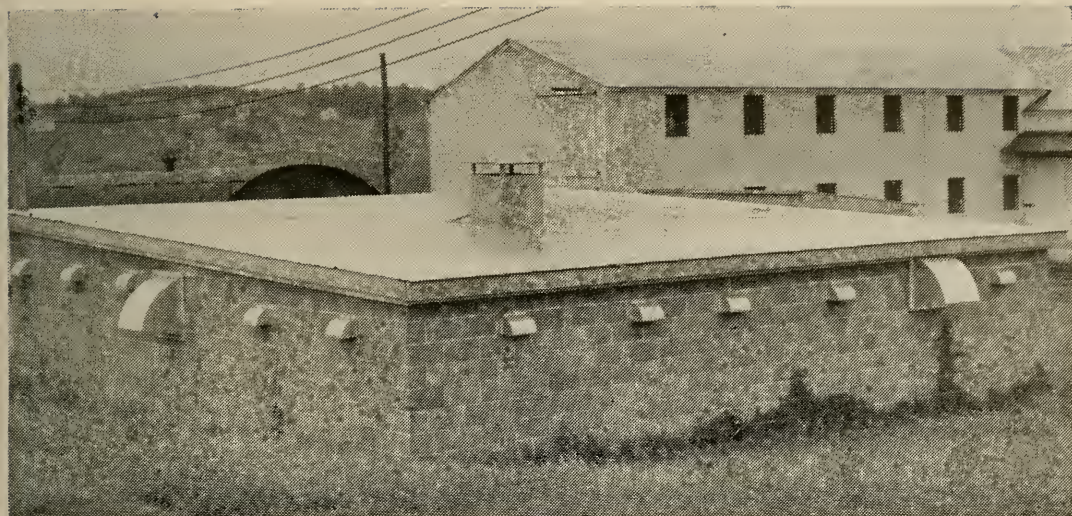
FIGURE 1. Windowless house showing original ventilation system of 24-inch exhaust fan in center of roof and small, hooded intake openings. This system was discarded in favor of a pressurized system. The large hoods in the walls cover the intake fans and exhaust openings.

Many changes were made in the ventilation system of this 30 x 30-foot house. Initially, a 24-inch propeller fan with a capacity of approximately 7,500 cfm was mounted in the center of the ceiling to exhaust air through the roof (Figure 1). The cores of blocks placed on their side at regular intervals in the wall served as inlets for the air. Various hoods, baffles, and ducts were used in an attempt to direct the air where it would do the most good (Figures 2 and 3). Ducts were erected within 15 inches of the litter to exhaust the air at bird height (Figure 4). All

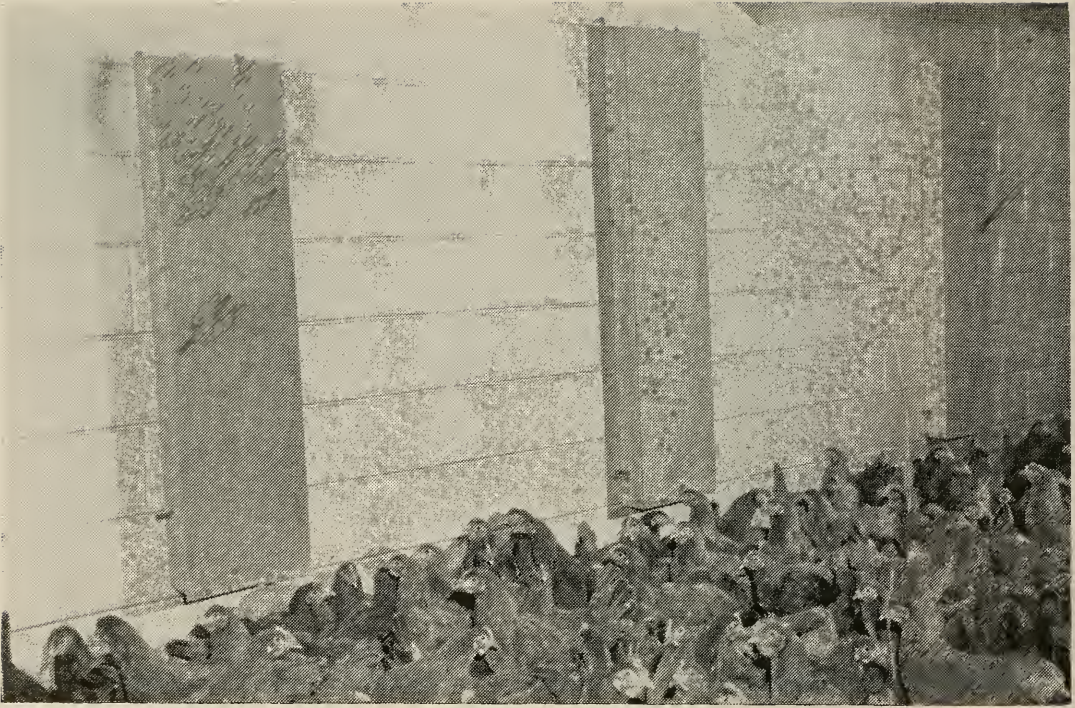
FIGURE 3. This baffle directed air to the floor, but the birds crowded around the base and they prevented good circulation.

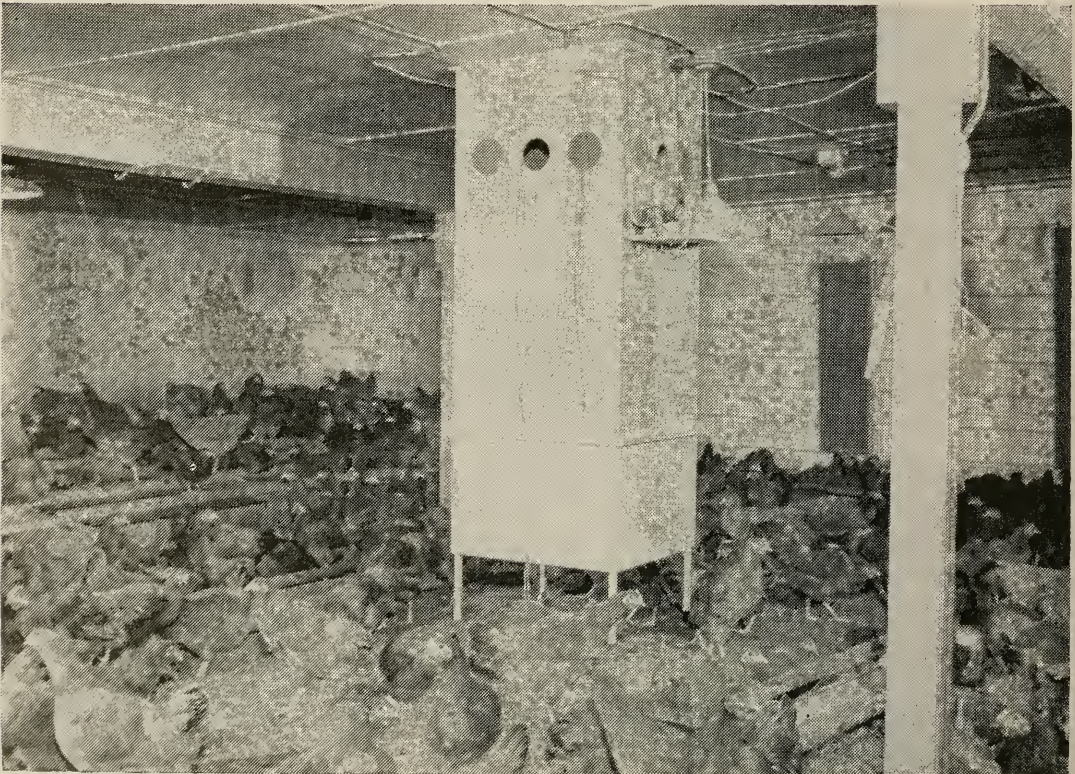
FIGURE 4. Exhaust duct in the center of the room. Small holes in the side of the duct provided some ventilation near the ceiling.

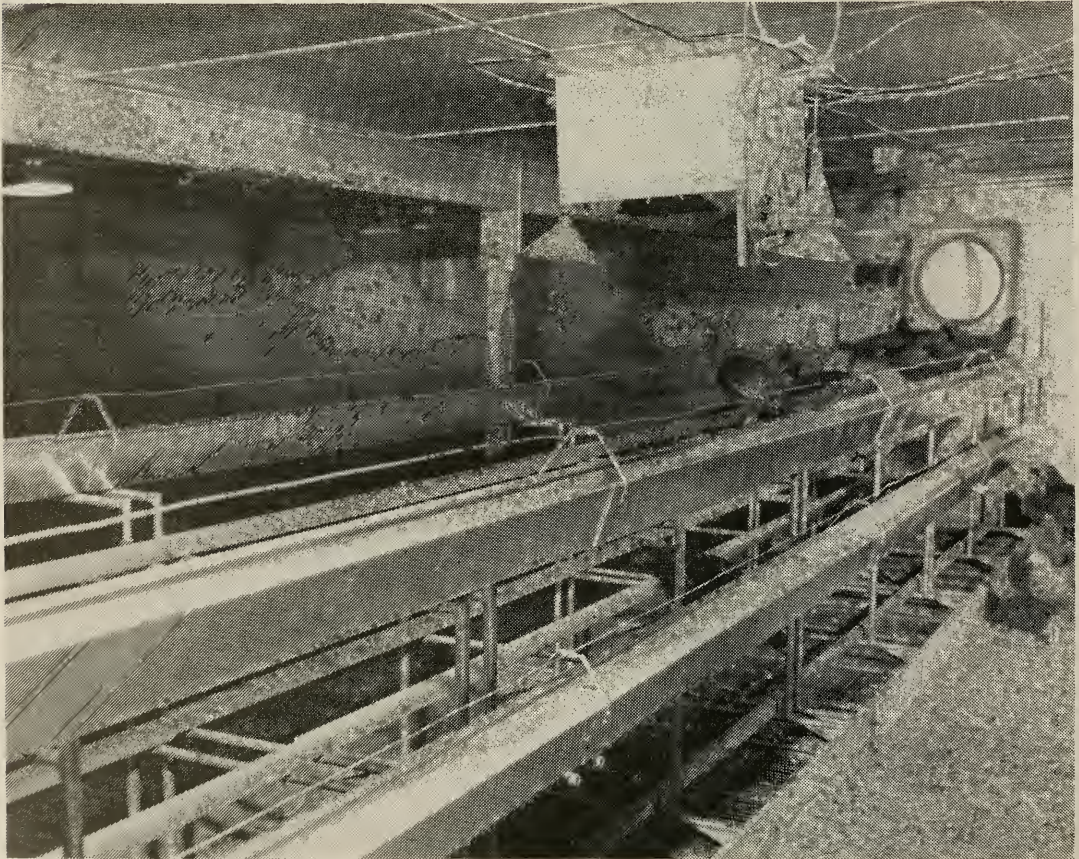
FIGURE 6. Multi-tier roosting assembly with feeding and watering equipment over a manure pit that is cleaned mechanically.

A concrete floor was poured the following year, and a 4-foot wide manure pit was constructed through the center of the house. This pit was equipped with a mechanical cleaner. Three tiers of roosts were installed to accommodate 450 White Leghorns (Figure 6). The installation of the mechanical pit cleaner did more to improve the living conditions of the birds than any other single innovation. On several occasions since, it was estimated that the cleaner removed about 75 per cent of the water excreted by the birds. This was a tremendous factor in maintaining satisfactory environmental conditions in the house. Less ventilating air was required because less moisture had to be removed. Thus, heat was conserved.

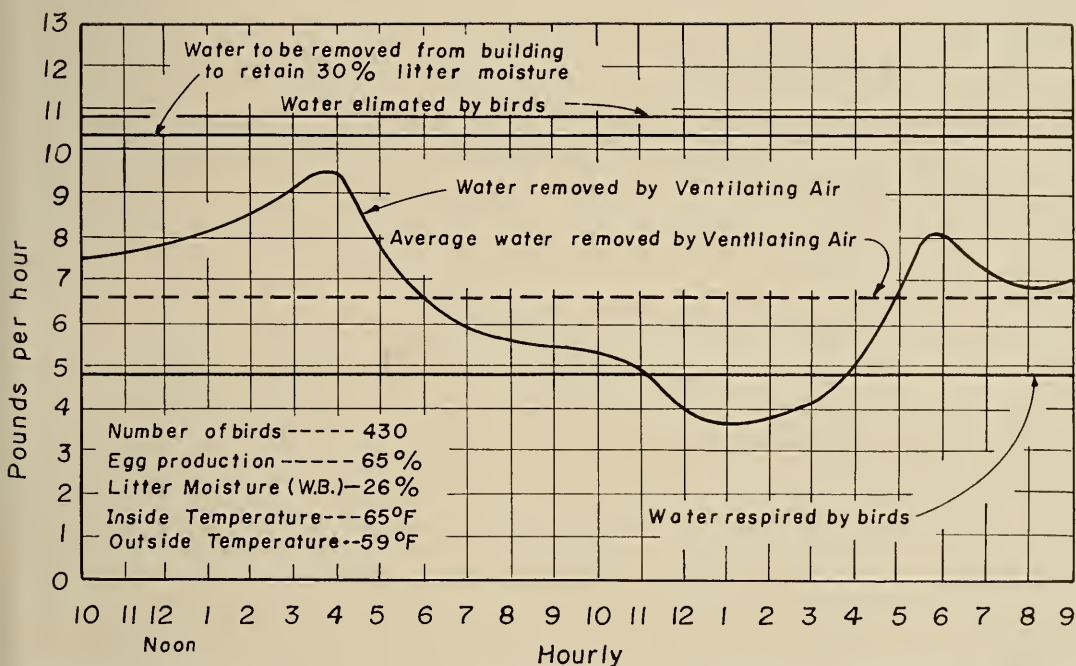
FIGURE 7. Water produced by birds and water removed by ventilation system and mechanical pit cleaner.

The value of the pit cleaner can best be demonstrated by making a calorimeter-psychrometric analysis of a week's data for the house. The calorimetric information was obtained from published data for poultry.* Hourly readings of temperature, humidity, and air flow obtained with potentiometers and operations recorders provided the psychrometric data (Figure 7). The data were recorded beginning at 9 a.m., for 24 hours, seven days each week. The solid curved line indicates the average amount of water removed by the ventilating air each hour of the day every day for one week.

The ventilating air should remove the required moisture as fast as it is produced in order to maintain good environmental conditions in the poultry house. It is also important to use a mechanical pit cleaner to remove the water in the droppings before it evaporates into the room. Litter should serve as a temporary reservoir for moisture—giving it up on good drying days, absorbing it on poor drying days. During this particular week, it failed to do so between 11 p.m. and 4 a.m., but the average rate of removal was 6.6 pounds of water per hour, whereas the rate of respired moisture was 4.84 pounds per hour.

be removed by the combined use of the ventilation system and pit cleaner in order to hold the litter moisture content at approximately 30 per cent (wet basis). Actually, the litter moisture content dropped 2 per cent during the week. As shown in Figure 7, the water removed by the pit cleaner was 10.35 pounds minus 6.6 pounds or 3.75 pounds per hour or 88 pounds of water per day. This was the same amount of water in 75 per cent of the droppings excreted by the birds estimated to be removed by the pit cleaner. Without the pit cleaner, moisture accumulation would have occurred in the litter.
